Full Length Research Paper

Monitoring of shallow landslide in Tun Sardon 3.9 km Pinang Island, Malaysia

The objective of this paper is to monitor the slope movement before a landslide occurrence. Inclinator, piezometer and rain gauge were installed to monitor the slope. In the study area, water level of all piezometers is showing cyclic trend correlated with rainfall intensity. Observation made on July 30th 2010 and November 4th 2010 show soil movement in positive direction (towards slope). A relation between soil movement and high intensity of rainfall during this period was inferred which can be consider as a potential threat for mankind.

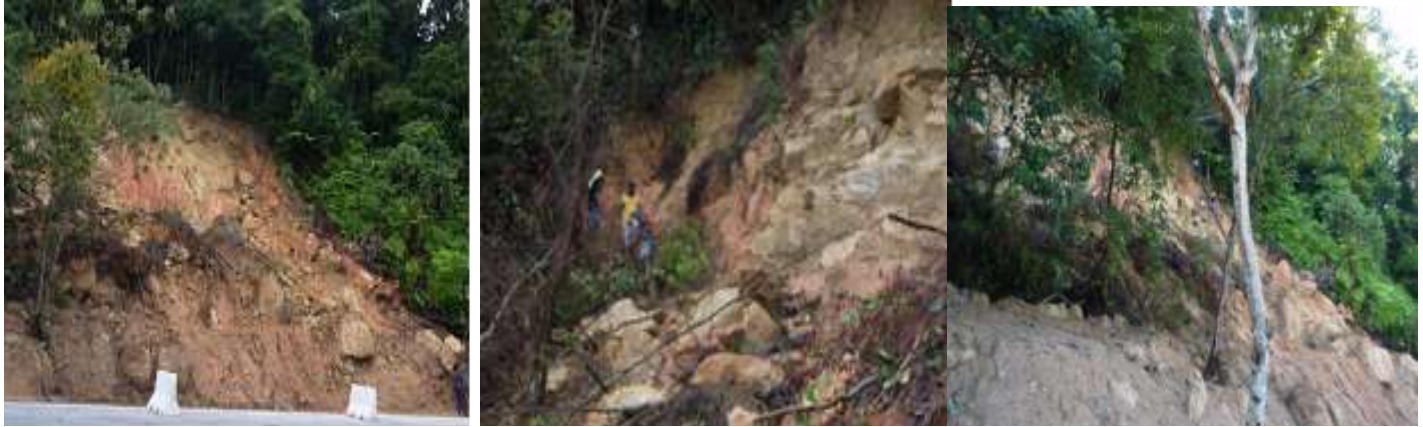
A shallow landslide occurred along at 3.9 km Tun Sardon roadside after a heavy rainfall event on September 6, 2008 in the Penang Island (Figure 2). The Tun Sardon event occurred due to a 160 mm of continuous rainfall in 8 h. The rainfall increases the pore water pressure as well as increases soil unit weight. After sufficient saturation, the residual soils might have caused the slope to fail (Habibah et al., 2009).

Figure 2. Landslide at 3.9 km Tun Sardon road of Penang.

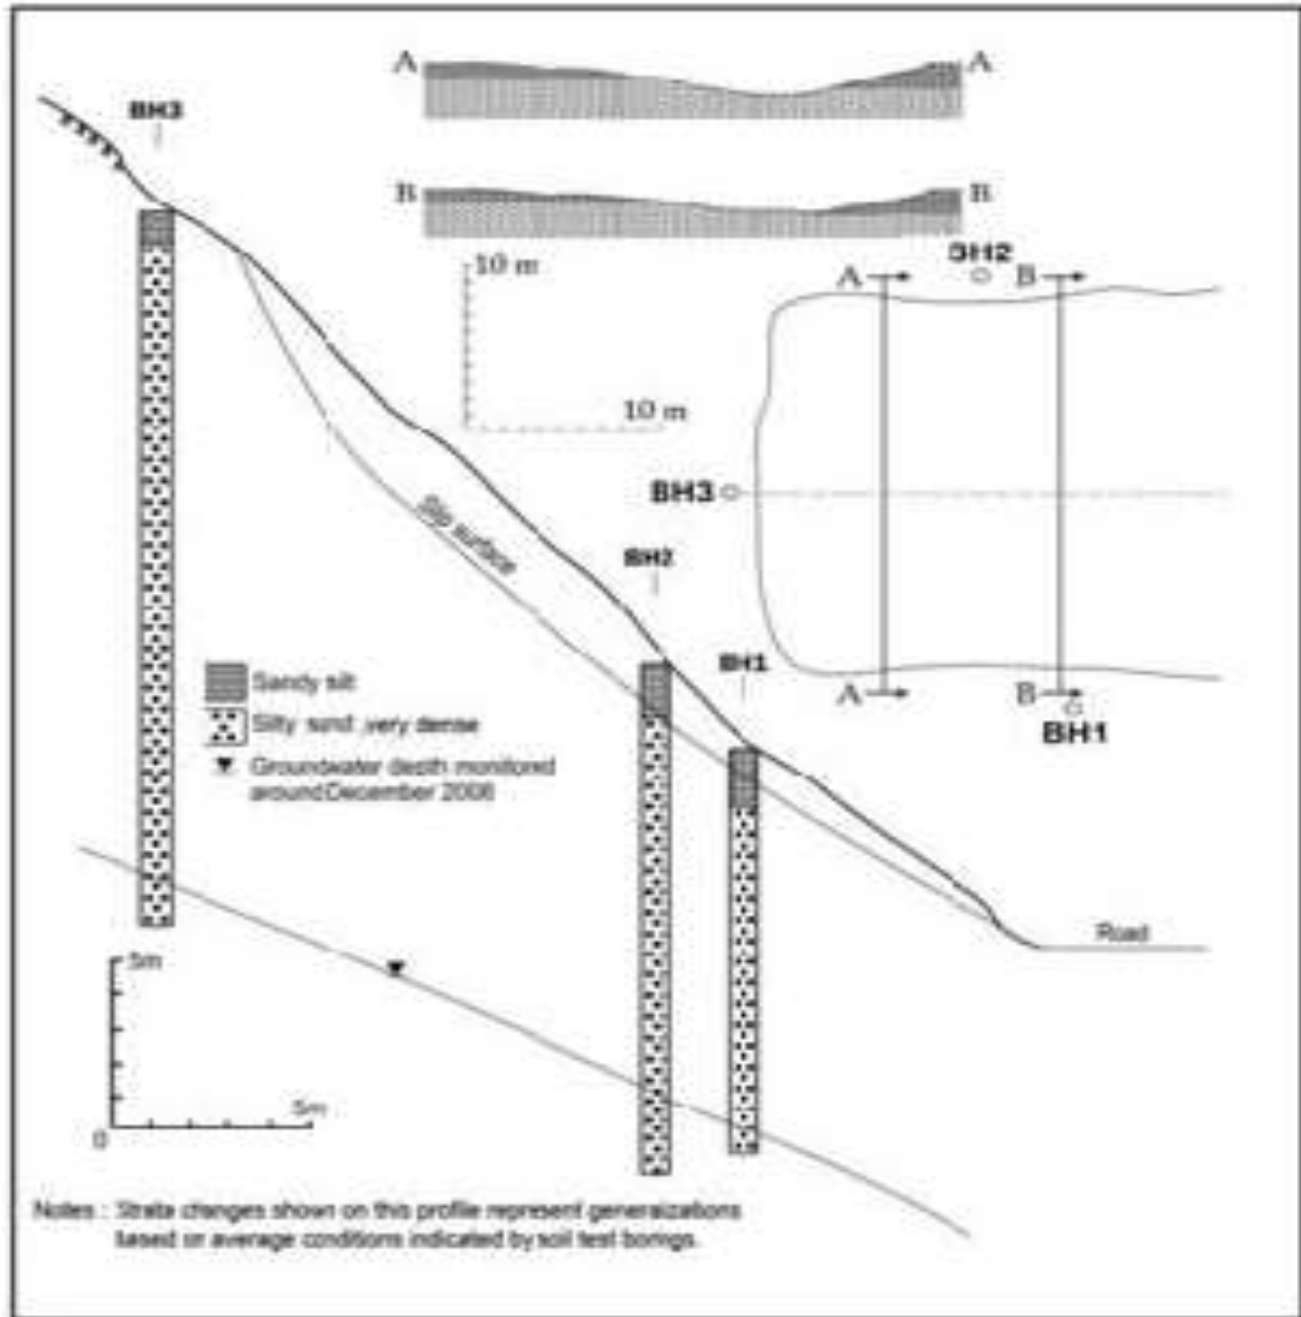
Classification of slope surface morphology was divided into planar slope, hollow and ridge. At 3.9 km of Tun Sardon road, it was classified as planar slope surface (Figure 5). Research on failure characteristic in Shikoku Island by Dahal et al. (2008) and supported by Avanzi et al. (2004) showed that slopes with hollow surface showed more landslide frequency. However, Jacobson et al. (1993) found that planar slopes are more susceptible to failure than other configuration of slope morphology. This analysis showed there were different results among researchers, although tendency of landslide for certain location is not only influenced by geomorphology. Sometimes the effect from impermeable bedrock was more than the geomorphological factor. The 3.9 km Tun Sardon road slope failure was a result of this factor.

Figure 5. Generalized subsurface profile of slope and cross section.

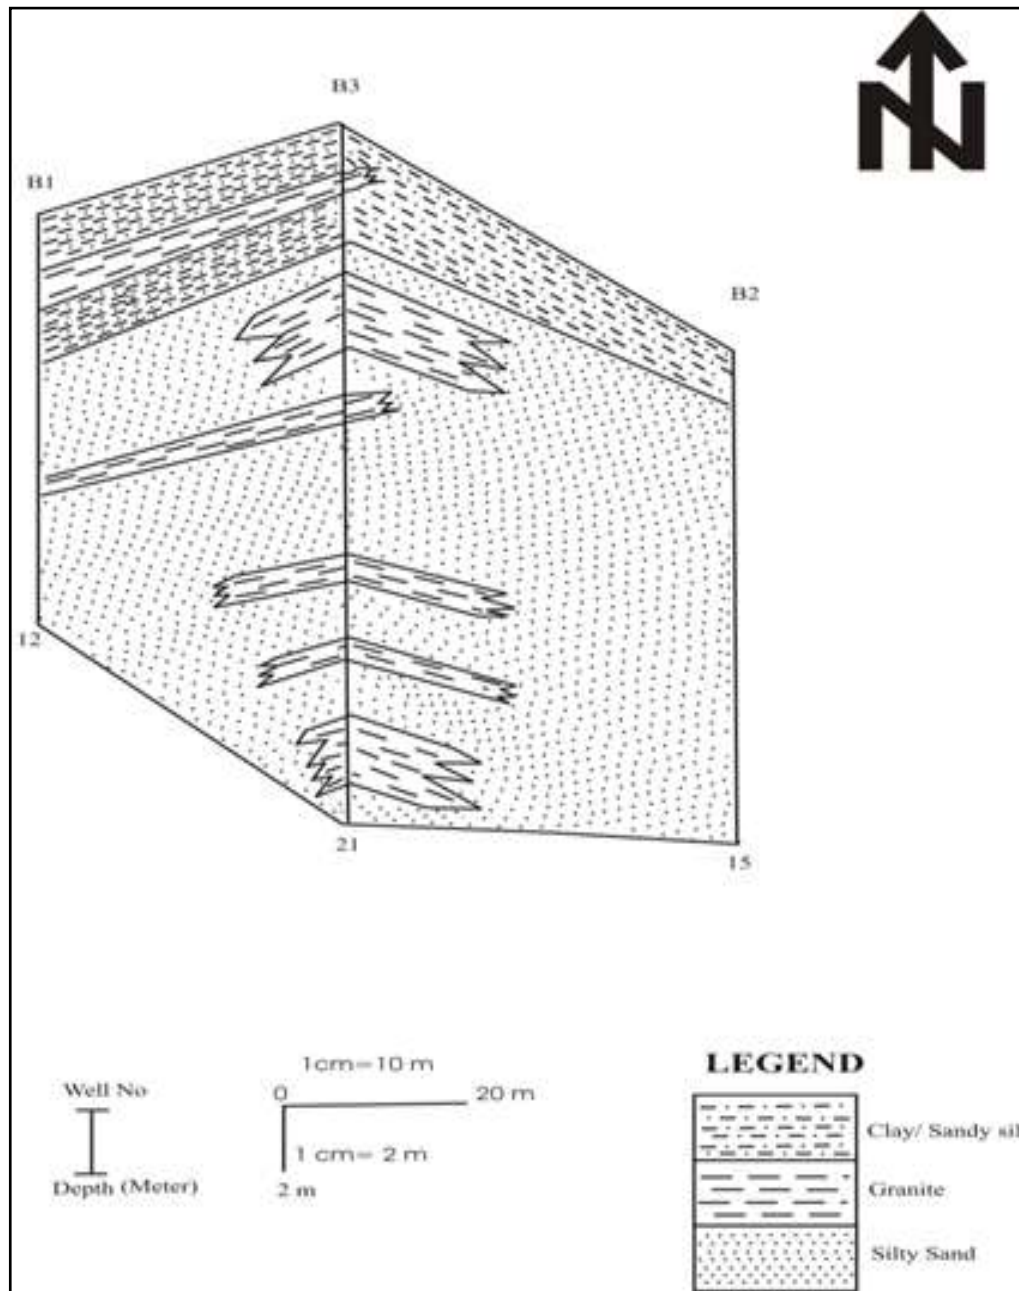
Figure 7. Fence diagram.

A fence diagram based on drilling logs of the bore holes drilled by the CE Instruments SDN BHD Malaysia has been prepared (Figure 7). The fence diagram depicts the vertical and lateral disposition of subsurface material in the study area to a depth of 21 m below ground level (bgl). A perusal of fence diagram shows the occurrence of a single aquifer (silty sand) to a depth of 21 m bgl. The top clay layer (sandy silty) is persistent throughout the area varying in thickness from 1.6 to 3.2 m. The material in this layer is fine to coarse grained and is dark brownish gray in color. This top clay bed is underlain by a single granular zone which extends downwards to different depth varying up to 21 m bgl.

This clay bed consists of one large granite lens, approximately 3.6 m long and at the most 1 m thick, which pinches towards B3 (NW). The granite is slightly to completely weathered, particularly along and adjacent to joints. Joints are close to very closely spaced and rough and undulating with dip varying from horizontal with

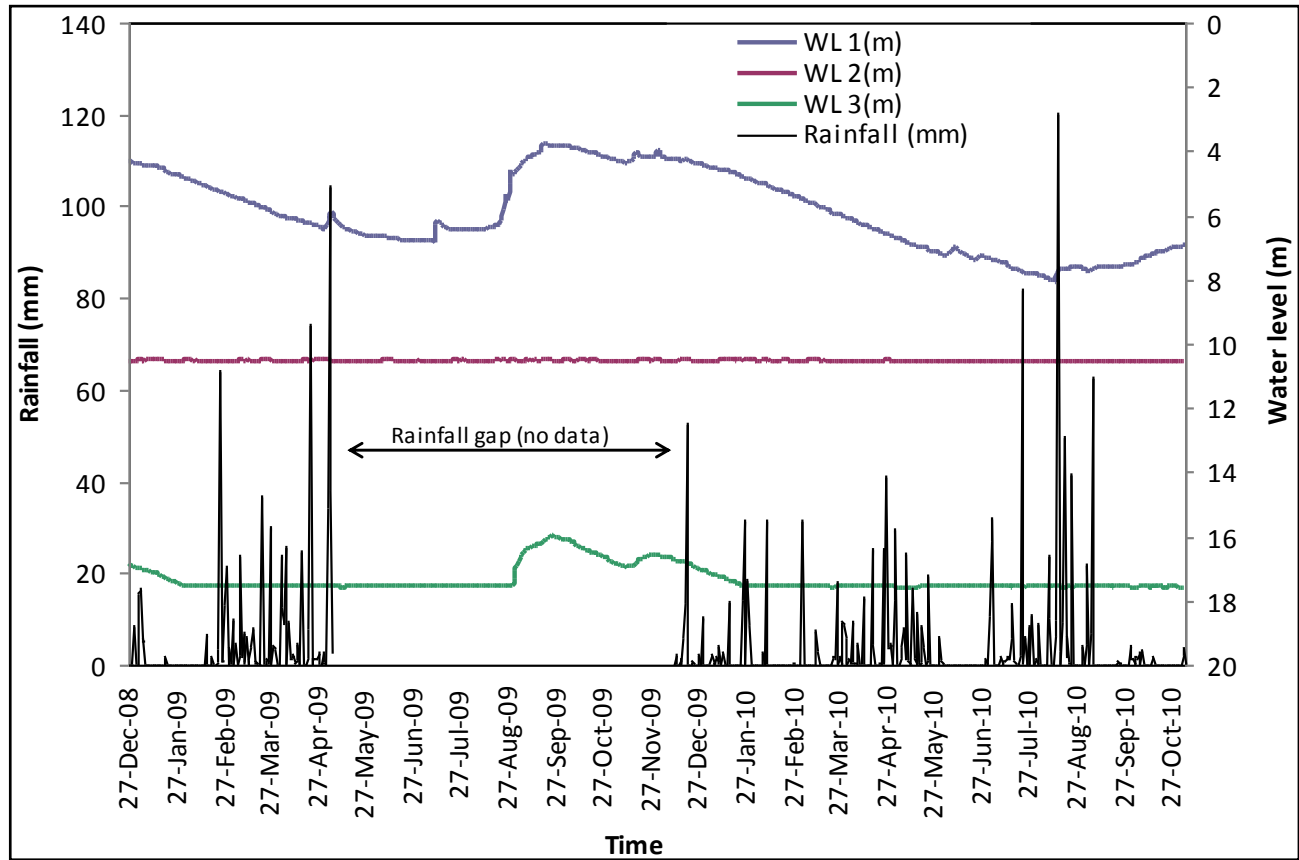
The daily rainfall data was collected from Tun Sardon rain gauge station. Graphs of daily rainfall and water level were (Figure 8) prepared to see the impact of rainfall on water table. The close analysis of the graphs shows that rainfall is a major source of groundwater recharge. This is depicted in the rise of water level at the end rainfall. Groundwater recharge is maximum in rainfall period and minimum in non-rainfall time period.

Perusals of these piezometric graphs indicate that the water level fluctuation is cyclic and sinusoidal as a function of time and space. Water level fluctuation within BH1 (WL1) and BH3 (WL3) coincides with the occurrence and non-occurrence of rainfall events. More precisely, water level rise lags the rainfall occurrence in WL1 and WL3. In paucity of groundwater abstraction, the decline or recession in water level is attributed to aquifer flows. Also some amount of water may loss due to vertical flows and joint leakages. Although, water level at BH2 (WL2) has acquired a flat trend not affected by rainfall events

Figure 8. Rainfall and water level relationship.

and subsurface flows. The flat trend can not be explained alone with the fact that it has got comparative flat gradient. One possibility is that the rainfall recharge and subsurface outflows go concurrently, thus, nullifying the effect of each other.

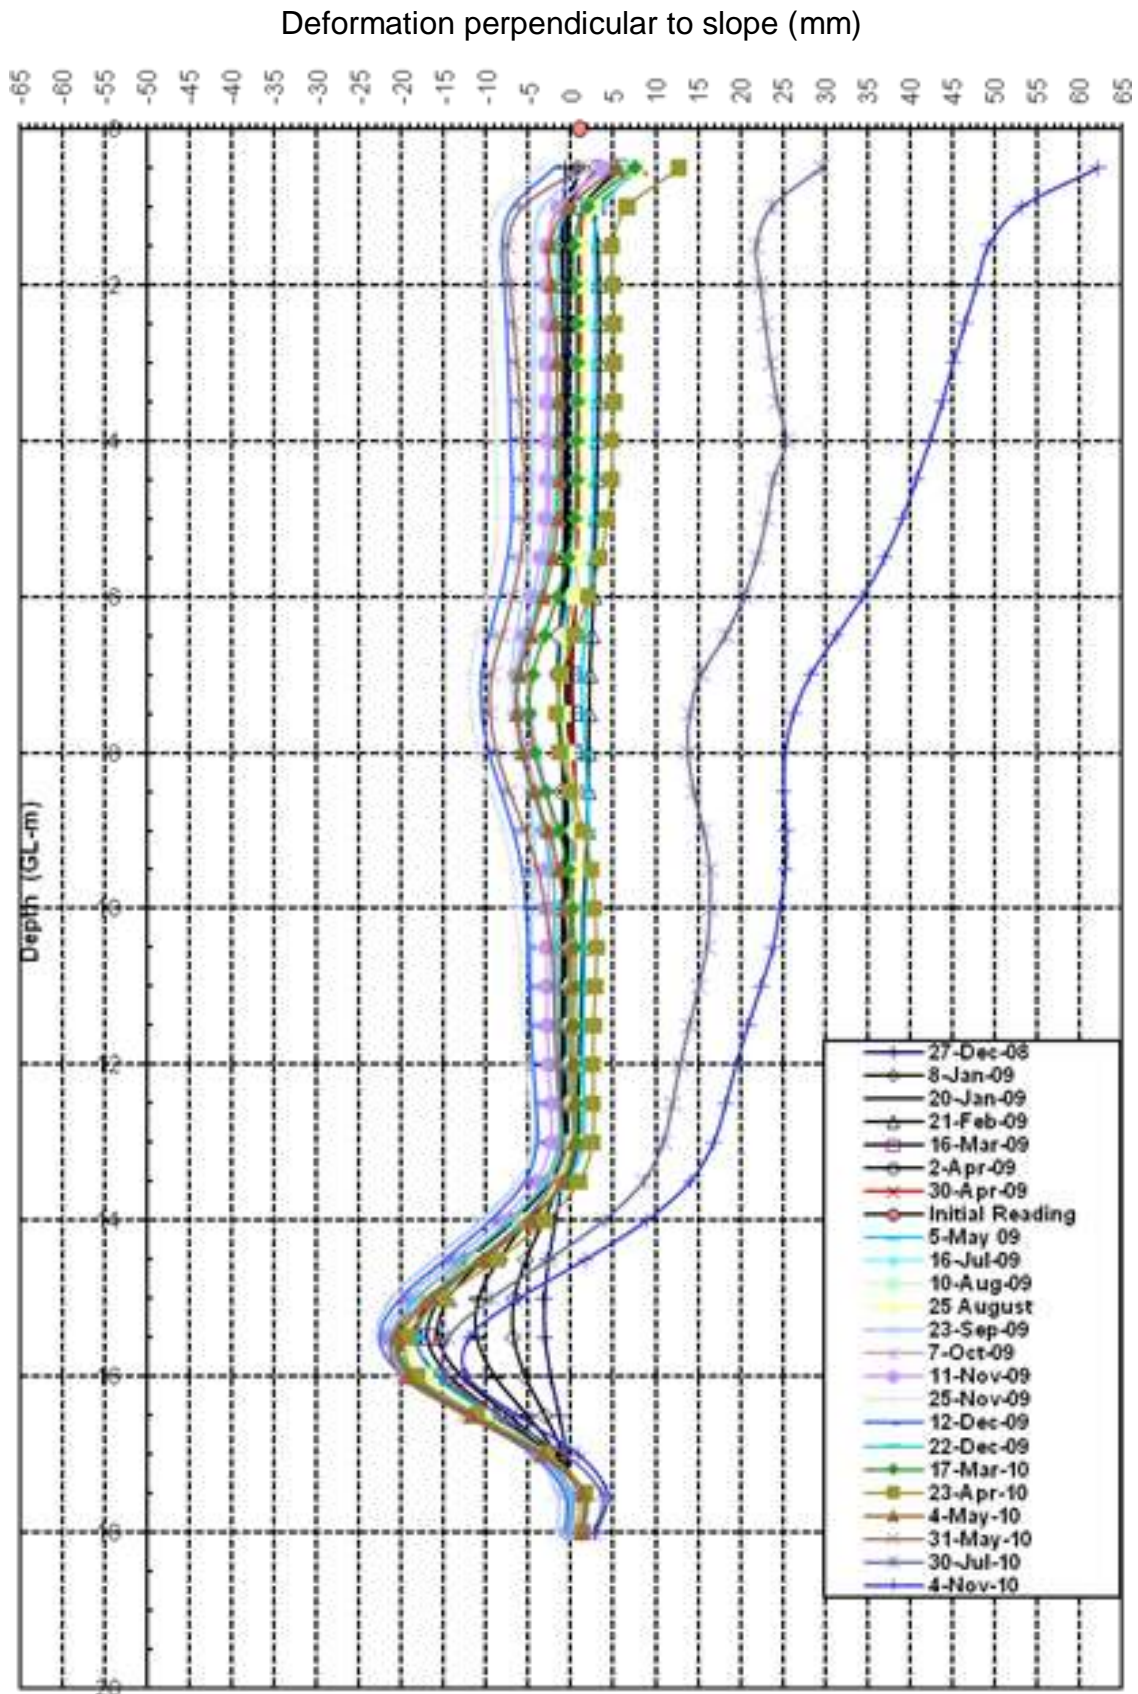
Slope movement (Figure 9), 14 to 18 m layer moved heading towards upslope with 18 mm and the maximum value was recorded on May 5, 2009. Probably instrument problem, loose packing of boulders during this particular depth, ground water flow, and road vibration due to heavy traffic which pressed on inclinometer casing has effect on the movement to upslope. From the field investigation, it has been observed that over all slopes of the beds is towards the road, that is, NW direction, so probably due

to the aforementioned effects the upslope movement occurred. From surface until 14 m depth, the soil movement on maximum down slope was less than 5 mm. But in 30th July 2010 and 4th November 2010, the slope movement attained was 60 mm up to the depth of 2 m. After this depth, the movement is showing reduction towards zero value. It can be concluded that the slope movement at shallow depth is due to intensification of rainfall event during this period. It is evident that the upper layer which is clay/ sandy silt up to 3.6 m may saturate due to high and continuous rainfall resulting in loose bearing capacity of soil particle which in turn induces surface movement. Therefore, the vulnerability of surface movement with high intensity rainfall event may prove disastrous for mankind.

Figure 9. Slope movement.

Landslide hazards in Pinang Island are common; the frequency of such hazards has been increasing in the last few years. The threat to lives, property and traffic is posed by severe landslides after heavy rainfall. Therefore, the present study suggests immediate need to establish a good meteorological and hydrological monitoring network in mountainous regions especially within landslide prone areas.
