Journal of Geology and Mining Research

Volume 7 Number 3 March, 2015

Assessment of effective factors in performance of an open stope using cavity monitoring system data: A case study

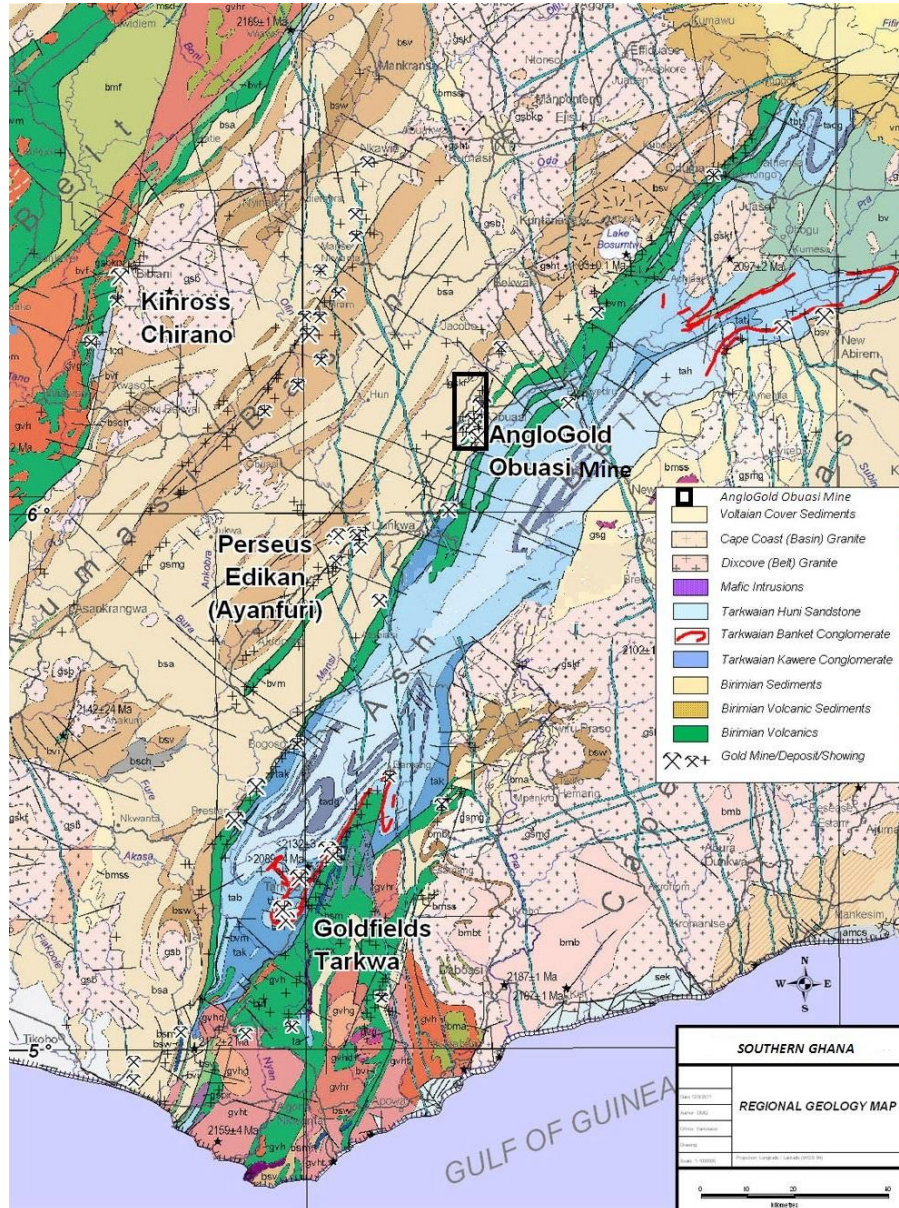
Figure 1. Location and geology map of AngloGold Obuasi mine and its environs.

Obuasi and its environs (latitude 5° 35' N and 5° 65' N and longitude 6° 35' N and 6° 90' N) in Adansi South Municipality, is about 56 km south of Kumasi, in the Ashanti Region of Ghana (Figure 1). The administrative capital of the municipality is Obuasi with hilly landform, and semi-equatorial type of climate (Dickson and Benneh, 1988). The vegetation is predominantly degraded and semi-deciduous forest.

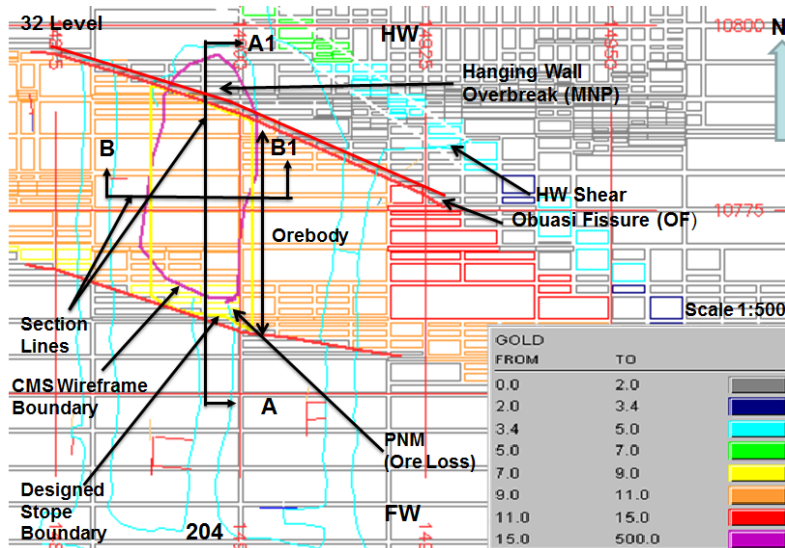
Figure 2. Block 1 32s 204 Stope; 32 level plan showing section lines (A – A1 and B – B1).

Further west of the OBF is another graphitic fissure (flatly dipping) referred to as Hanging Wall (HW) Shear (Figures 2 and 3). The two fissures (OBF and HW Shear) intersect somewhere north of 32S 204 stope. The sulphide lode, which occurs in widely spaced jointed metasediments (mostly greywackes and phyllites), is considered the principal Ore body in Block 1. The ore shoots (quartz reef and sulphide lode) dip approximately 68° NW (Figure 4). Where widths of ore shoots from foot-wall to the hanging-wall exceed 10 m, mostly in the northern section of the Block 1, transverse open stoping mining method is practiced using primaries and secondaries adjacent to backfilled panels. The 32S 204 stope is a primary transverse stope in Block 1 Upper, with 32N1 Level as the

This makes development location and undercutting of the OBF, very crucial in the stope performance analysis. On both 32 and 32N1 levels (Figures 2 and 3) the crosscuts were developed to intersect the OBF. The OBF was actually crossed and further developed into the hanging wall (Figure 4). Thus, on both levels the OBF had been undercut with crosscuts. Again, the reef drive “Tees” were developed in both the OBF and the sulphide orebody (Figures 2 and 3). Hence part if not all of the thickness of the OBF for the entire stope strike length had been undercut. This situation caused variations in the angle between stope surface and OBF and stope surface dip a situation likely to affect *in-situ* stresses and their distribution. Numerical modelling of the tension around

Considering Figures 2 to 4, it can be adduced that the breakups had direct relationship with high magnitudes of energy from heavy blast vibrations that occurred in the stope. This might have caused the severity of rockmass overbreaks. The reduction in rockmass quality most likely paved way for weakening or dilation of existing discontinuities in the stope. Such situations created new fractures to further cause hanging wall instability. This information is crucial for ground control, support, and dilution estimation. Down blast-holes drilled in the stope were 76 mm in diameter and the pattern was (2x2 m). This practice must be adhered to, to prevent blast-induced damages. Yu (1980) is of the view that large diameter (200 mm) blastholes cause excessive stope wall sloughage. Explosive product (high or low density),

The entire overbreak tonnage, mostly barren wall rock from the hanging wall (Figures 2, 3 and 4) of 32s 204 stope, diluted the ore in the stope. The planned grade of 8.94 g/t was reduced on completion of mining activities to 7.97 g/t (Table 1), representing -0.97 g/t drop in grade to compromise profitability. The term 'overbreak' is synonymous with unplanned wall dilution (Yao et al., 1999). This situation resulted in 16% unplanned dilution (Table 1 and Figure 6).

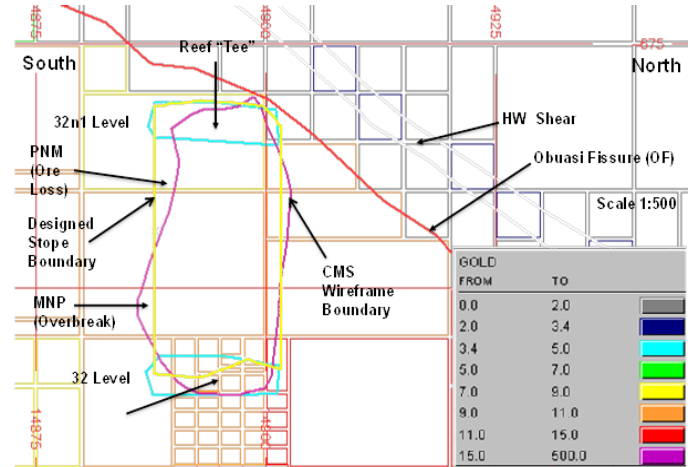
Figure 5. Longitudinal Section along B – B1 of Block 1 32s 204 Stope, showing lateral Overbreak and Underbreak.

These quartz reefs have varied geometries, with the widest veins produced at intersections where spurs splay off the OBF. On the other hand, the 12/74 is at most a metre thick with graphitic infill without quartz lenses. Two sets of joints ($310^{\circ}/75^{\circ}$ SW and $290^{\circ}/72^{\circ}$ NE) classified as shear joints (Sinclair et al., 1978) are prevalent in the ore shoots. The OBF in-filled with auriferous quartz reefs that mark the 32S 204 Stope hanging wall; the associated sulphide lode (arsenopyrite disseminated) footwall rock of the Block 1 mineralization is illustrated with grade models on 32 Level plan (Figure 2) and 32N1 Level plan (Figure 3). Figure 4 is a cross section (looking north) drawn along section line A-A1 shown on 32 Level plan, and Figure 5 is a longitudinal section (looking west) drawn along B-B1 also shown on 32 Level plan.

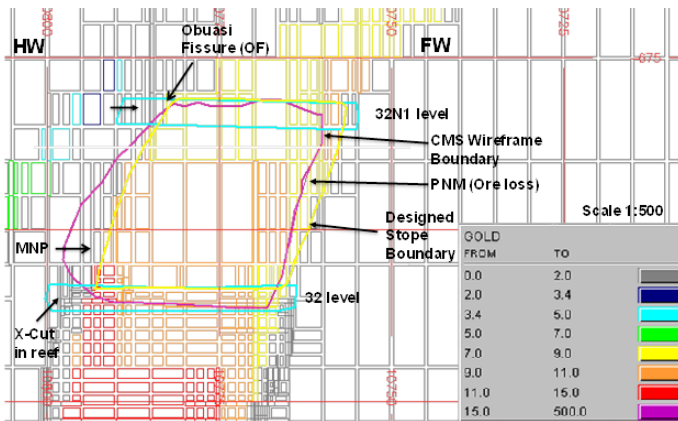
Figure 4. Cross section along A – A1 of block 1 32s 204 stope (looking North).

upper level and 32 Level as the lower level (Figure 4). The dimensions of the stope are: strike length, 17 m; width, 30 m; height, 27 m, and average dip of 68° NW. On completing the mining operations in 32S 204 stope, the survey department conducted the CMS underground survey using Optech V400 (an auto scanning laser instrument) to pick the final excavated void of the stope, orientation and volume. The instrument as modern graphical interface and therefore uses real-time data streaming and built-in post-processing mechanisms to verify collected data and georeferences while in the field.

The very close proximity of the OBF to the stope, being the actual 32S 204 stope hanging wall boundary, may also have had some influence on the overbreak in the stope hanging wall. The parallel positioning of the OBF as the stope hanging wall boundary had caused serious overbreak, especially from the toe to almost the crown

(Figure 4). The OBF, with average thickness of 1m made sloughage important due to its lack of cohesion (Villaescusa and Cepuritis, 2005). Tension zone areas around the developed stope crosscuts, reef drive “Tees” and slot raise are dependent on factors that include; the distance of the OBF from the stope surface, angle between the stope surface and the OBF, stope surface dip, *in-situ* stresses, stope aspect ratio and OBF shear strength (Suorineni, 1998). In this particular case, the OBF is the stope surface. Thus, tension zones could be used to estimate the possible stope hanging wall overbreak.

Considering the general stope dip 68° and exposed hanging wall area, not much overbreaks will occur. The 30 m stope width eliminates border effects (Vallée et al., 1992) as the stope is wide enough to reduce unplanned dilution should the stope walls fail. This may be one of the reasons why the final achieved grade dropped by - 0.97 g/t (Table 1) compared to the planned grade 8.94 g/t, else it would have been a significant drop. Even though large waste material overbreak occurred on the hanging-wall, the foot-wall side of the stope had 5439 tonnes at 8.76 g/t ore underbreak (Figure 4).

broad enough such that defined stope dimension does not show much geometric complexities. The stope had planar surfaces 17x30x27 m (Figures 2 to 4) and could be classified as being regular (Germain et al., 1996). This stope geometry coupled with few joint planes will not have serious overbreaks. Consequently planned dilution material was just 155 tonnes (Table 1). This geometry most likely controlled surface performance by distributing stress around the stope (Laubscher, 1990; Deere, 1973, 1979). Again with a stope aspect ratio of 1.1 (largest lateral dimension divided by height) and dip of 68°, no serious overbreak is expected (Suorineni, 1998) because the stope is not too high.

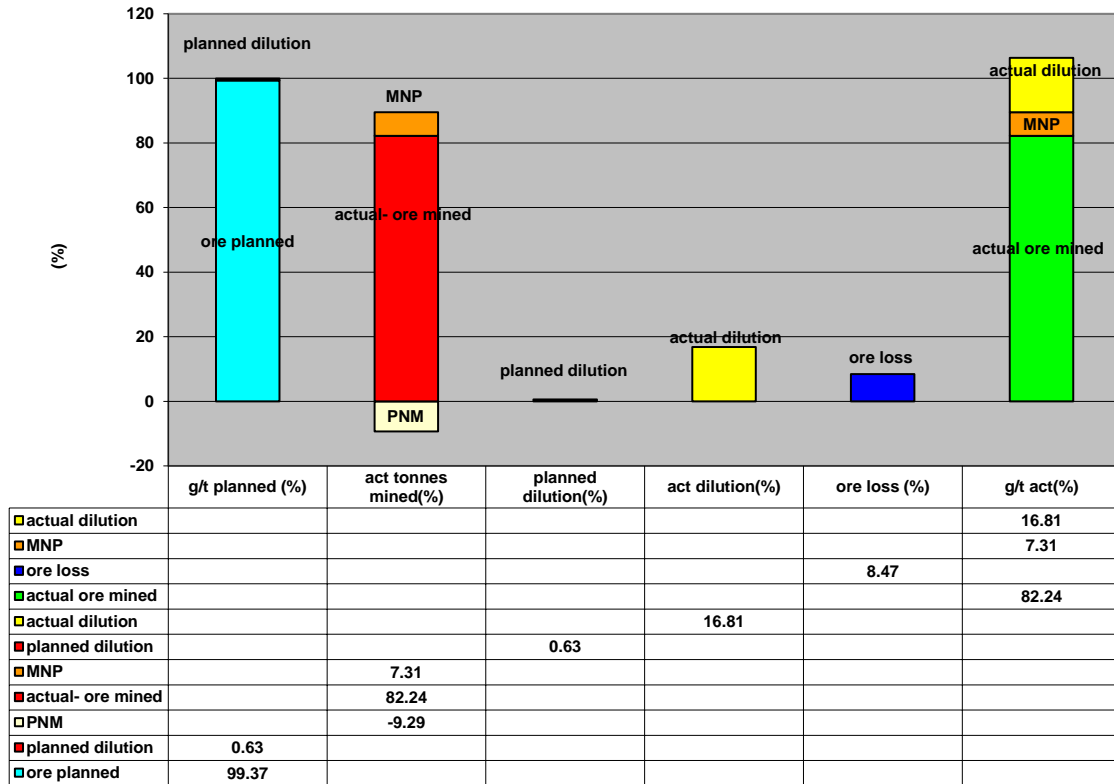
Figure 6. 32s 204 Stope performance graph.

Summarized statistics of planned information (tonnes, grade, ounces and dilution) and the stope reconciliation report are presented in Table 1, and the broken ore analysis in Figure 6. It shows that over 11,600 tonnes of ore with an envelope of 155 tonnes of waste at a grade of 8.94 g/t was planned to be mined to produce about 3380 ounces of gold; this excludes stope development materials. However, under 10,500 tonnes of ore and over 2,000 tonnes of waste materials were mucked from the stope; the achieved grade was 7.97 g/t and 3,228 ounces of gold obtained (Table 1). Thus, the variance was -1,142 tonnes of ore, with a corresponding grade of 0.97 g/t and 154 ounces (5%) of gold lost; this increased dilution from the under 1% planned to 16%. From the reconciled planned and mined tonnages, it was found that 920 tonnes of ore was mined that was not planned for, and over 5,500 tonnes of ore planned to be mined was lost (Table 1). Approximately 4,000 tonnes of ore was obtained from stope development activities, whereas a little over 2,000 tonnes of waste was mined that was not planned for; yet, part of the planned waste was not

mined. Of the approximately 90% total ore mined (Figure 6), 82% came directly from the planned stope leaving 7% behind not mined, and about 7% coming from unplanned areas. Though 5% gold loss was budgeted, about 9% was lost on completion of stoping (Table 1).

The approximately 8.5% ore loss (Figure 6) could have compensated for some of the unplanned dilution that occurred in this stope.

The 32S 204 stope produced about 83% of the planned ore (Figure 6) and therefore could be said to have performed well. However better result would have been achieved had dilution been drastically reduced from the achieved 17% to something close to the planned dilution of 1%. The CMS data had assisted in identifying overbreak and under-break, their nature, extent and morphology. It had brought to the fore that in the Block 1 ore shoot, the OBF is critical factor that needs serious attention when designing stopes due to its nearness and graphitic infills. The OBF had had control on rockmass quality and subsequent influence on the levels of overbreak in the hanging wall.
