*Full Length Research Paper*

# Geomorphology and climate conditions that determine sedimentation in Mamaia bay

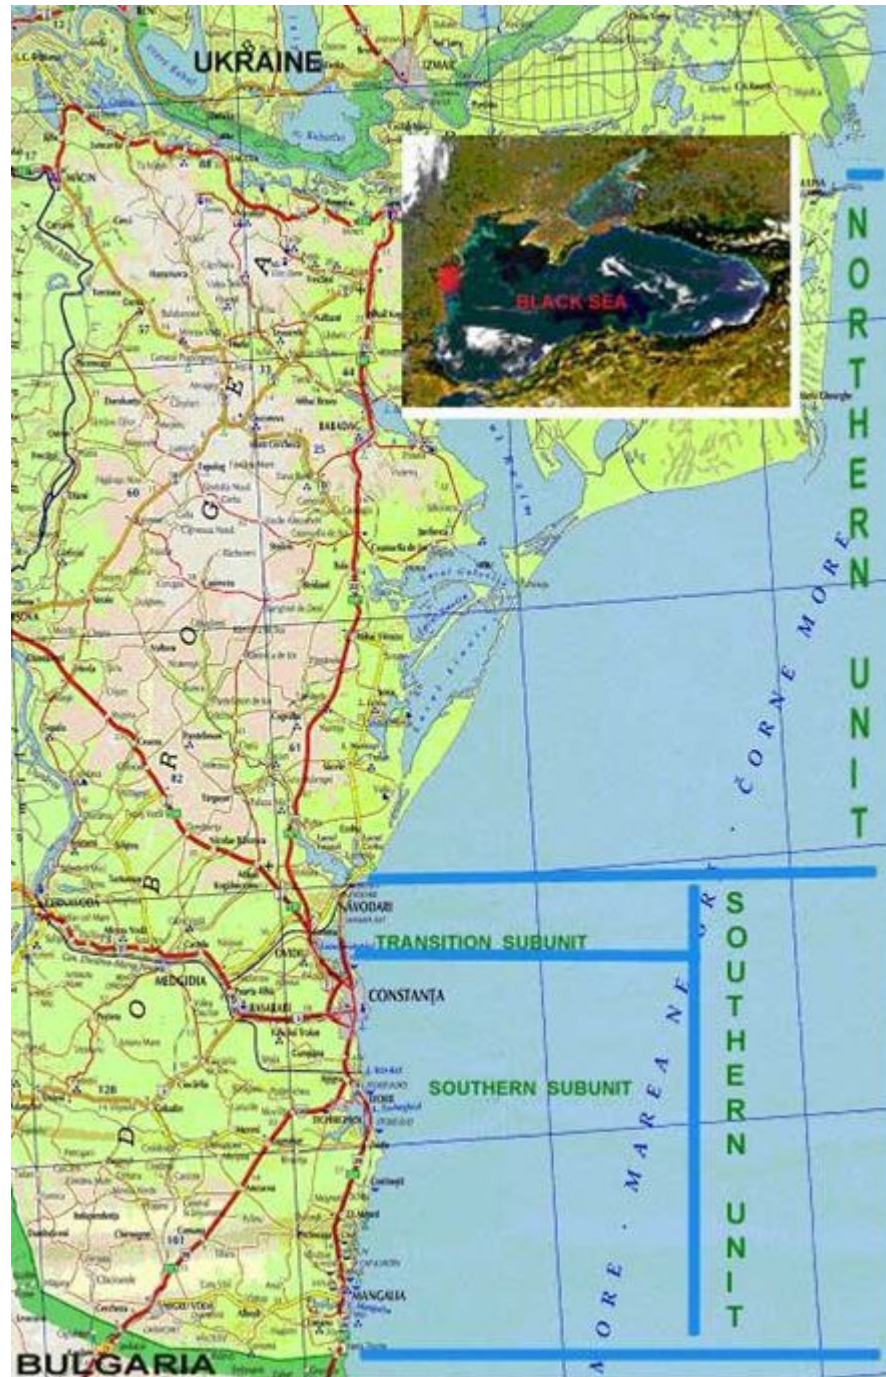
Figure 1. Romanian black sea coast.

It is well known that the Romanian Black sea coast is divided genetically and geomorphological (Panin et al., 1999) in two main units (Figure 1):

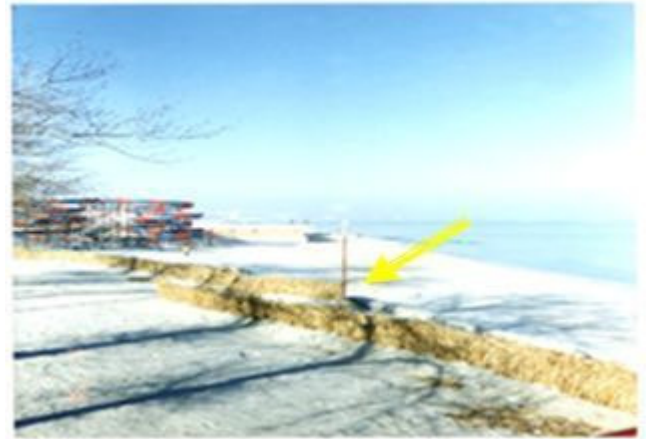
**Photo 2.** Soft beach protection measure with reed fences during cold season (13 I 2002).

- e) The placement of reed fences on the beach during the cold season, in order to protect the sand from the wind's direct affliction. (Photo 2). This measure is efficient and used all over the Mamaia tourist beach.

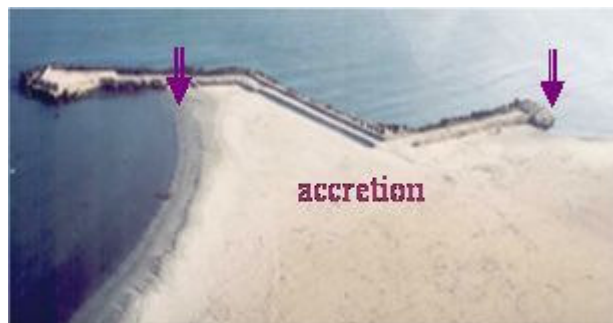
**Photo 3.** Local effects of accretion on the backshore - groin in southern part of Mamaia bay (13 I 2002).

first brought up in the year 1975 (Tanase et al., 1992), when the dangers of destroying Parc hotel's pool became imminent (south part of Mamaia beach). In the winter of 1977 to 1978, a groin was built, its actions being supported through beach nourishment brought from Tăbăcărie Lake (about 27000 m<sup>3</sup> sand). This groin had an important role in protecting the local beach but it is also an obstacle by retaining littoral drift which affects the adjacent beach. Thus, depending on the direction and sedimentary transport, this hydro-technical structure represents a sedimentary trap, which determines the accretion/erosion process (Photos 3 and 4).

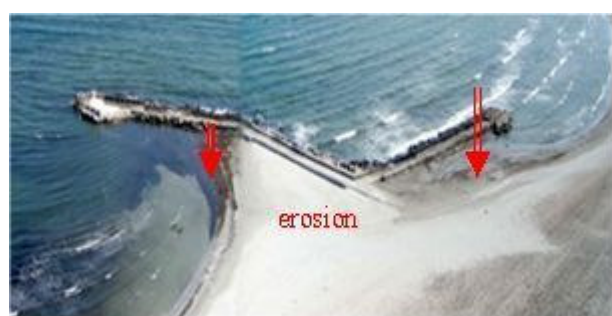
**Photo 4.** Local effects of erosion on the backshore - groin in southern part of Mamaia bay (17 III 2003).

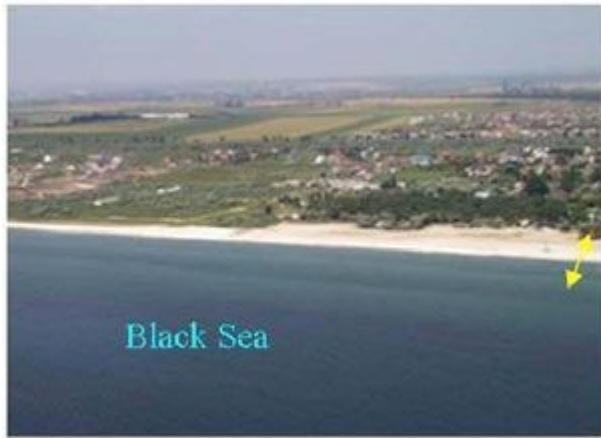
Photo 5. Beach connected to land (MM1).

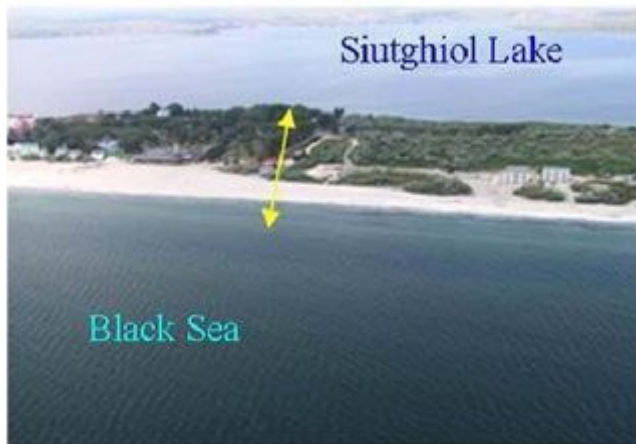
Photo 6. Barrier beach (MM3).

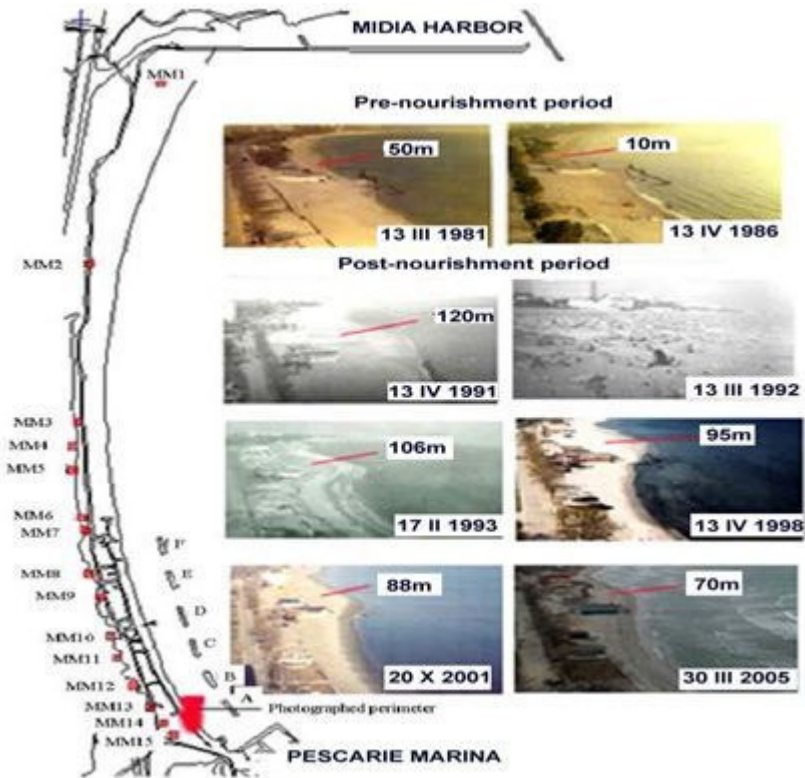
Figure 4. Backshore evolution at the sea-land interface (MM14, Mamaia beach, 1981 to 2005).

and 1988 (from 50 to approximately 5 m), and once the coastal protection measures were applied (detached breakwaters and beach nourishment), the beach was rebuilt (125 m wide in 1991 and 106 m wide in 1993) (Figure 4). In the next phase, the erosion process became dominant, as the beach reconstruction measures, with sediment supplies (from the Siutghiol Lake), were discontinued, the beach reaching a width of 70 m in 2005 (Figure 4).

The sea-land interface contour, as an effect of the protection dams in the swash zone, assumed a certain rhythmicity, due to the formation of salient sedimentary units (Figure 4: Picture 17 II 1993 / 30 III 2005). Thus, in the central protection area of the normal shore line, these sediment formations developed.

The sediments that were used from the Siutghiol Lake for reconstructing the beach had a considerable contribution of very fine particles. That is why, one year after the sanding, in the backshore area close to the MM14 landmark, during the summer season, several portions of wet beach appeared, while during the cold season, “buckets” made of very fine sand and coarse silt could be seen (Figure 4: Picture 13 III 1992).

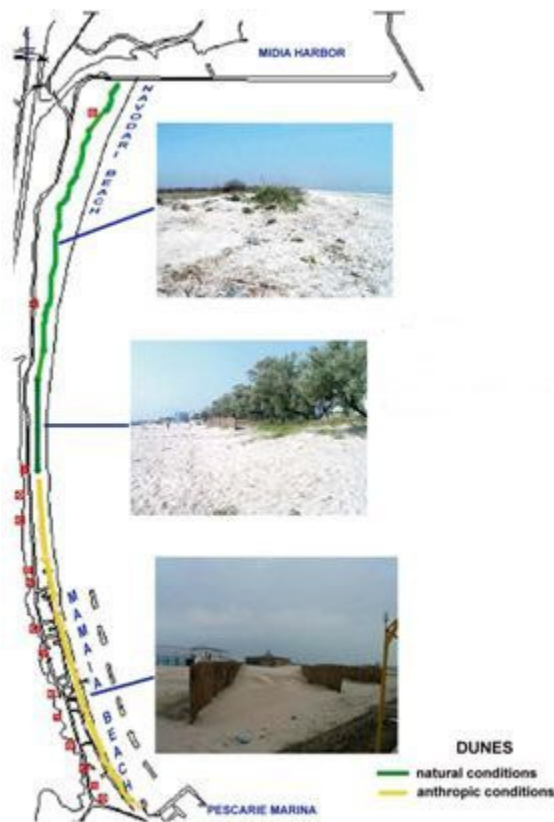
Figure 6. Dune sectors in Mamaia bay.

All throughout the 12.5 km-long backshore of Mamaia bay, about 50% of the area is covered by dunes, especially in the central sector, where they are stabilized by vegetation, and about 40% of the beach dune-type sediment units are formed during the cold season, as an effect of the protection measures that were used in the Mamaia resort (Figure 6).

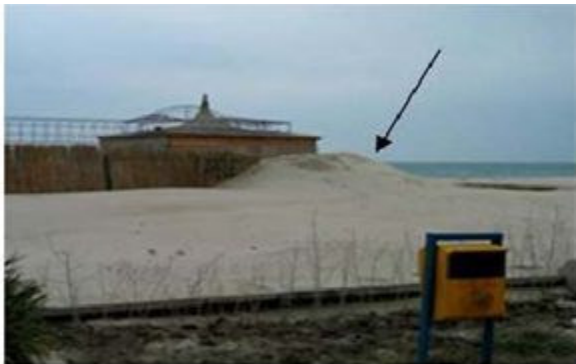
Photo 7. Sediment deposits winter season (23 November, 2004).

On the Mamaia tourist beach, during the cold season, dune-type sediment units were formed, as an effect of soft protection measures - reed fences. These units are redistributed by beach profile leveling during summer (Photos 7 and 8).

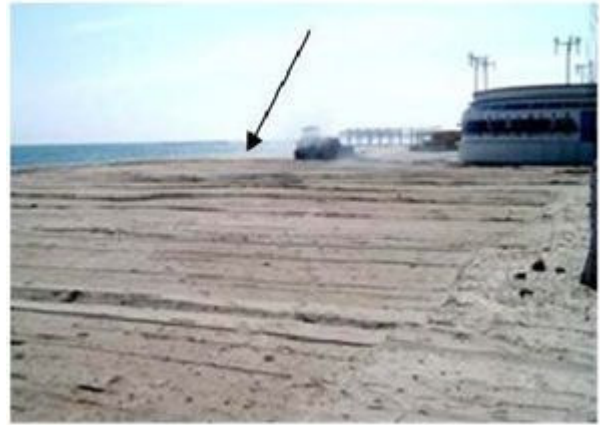
Photo 8. Beach shore leveling summer season (2 April, 2004).
