Full Length Research Paper

Assessment of the impacts of gully erosion on Auchi settlement, Southern Nigeria

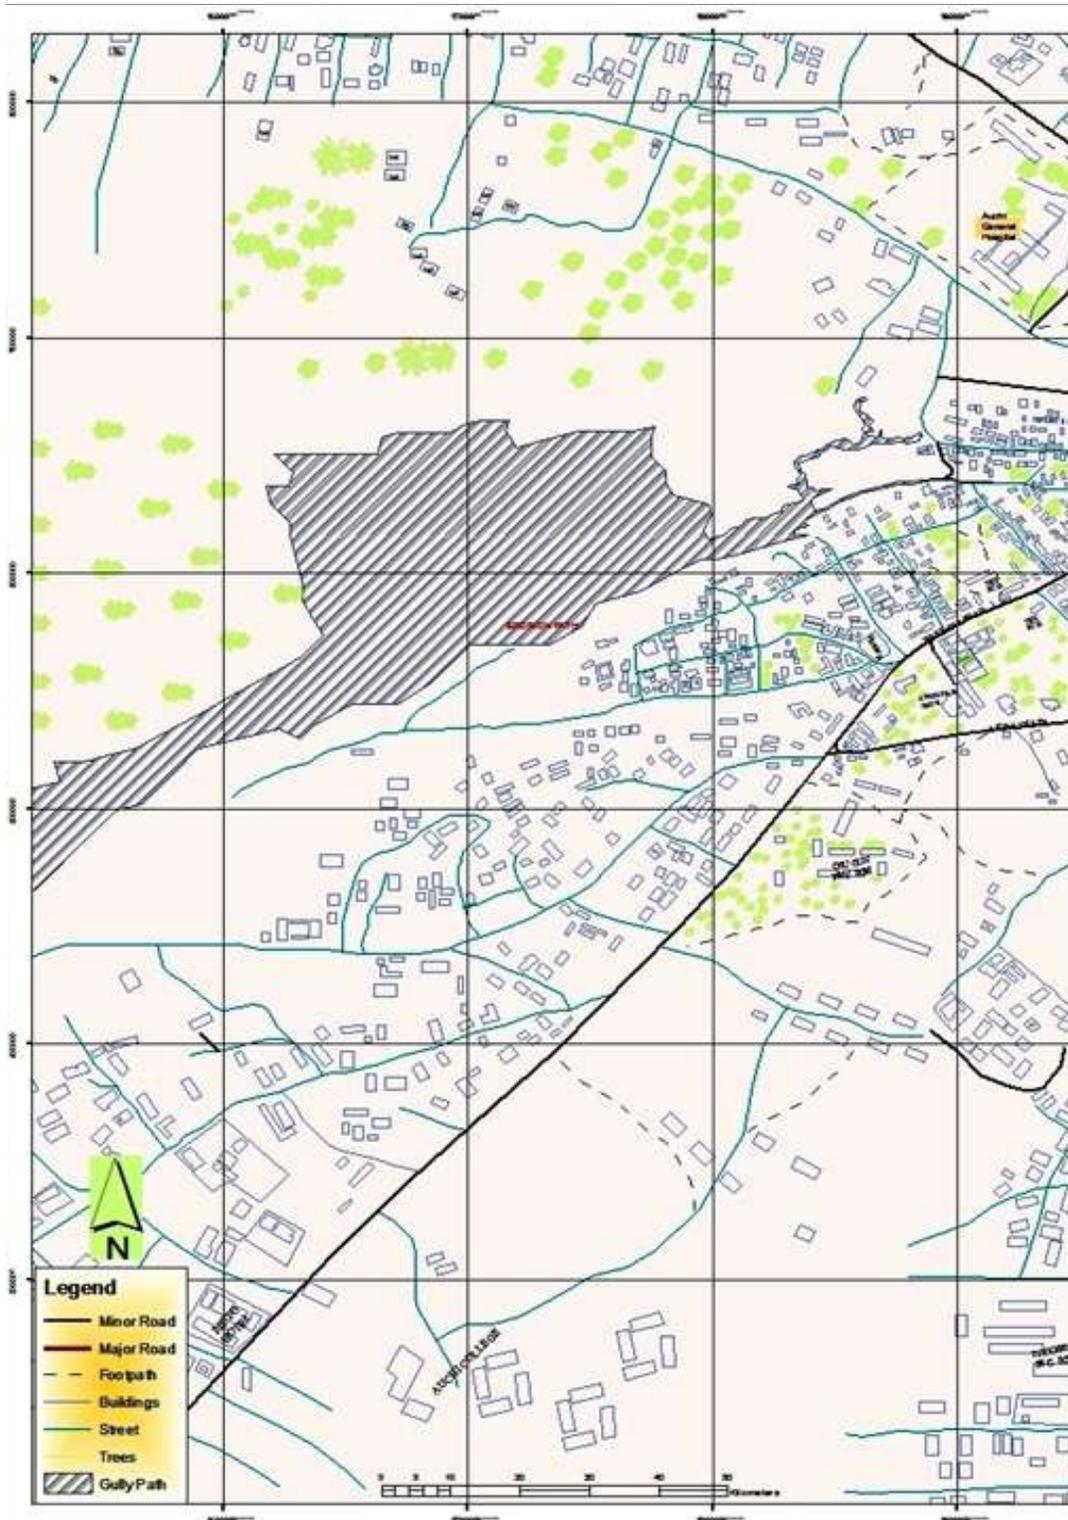
Figure 2. Auchi showing Land uses and Gully paths (Source: Produced from Archmap 10.1).

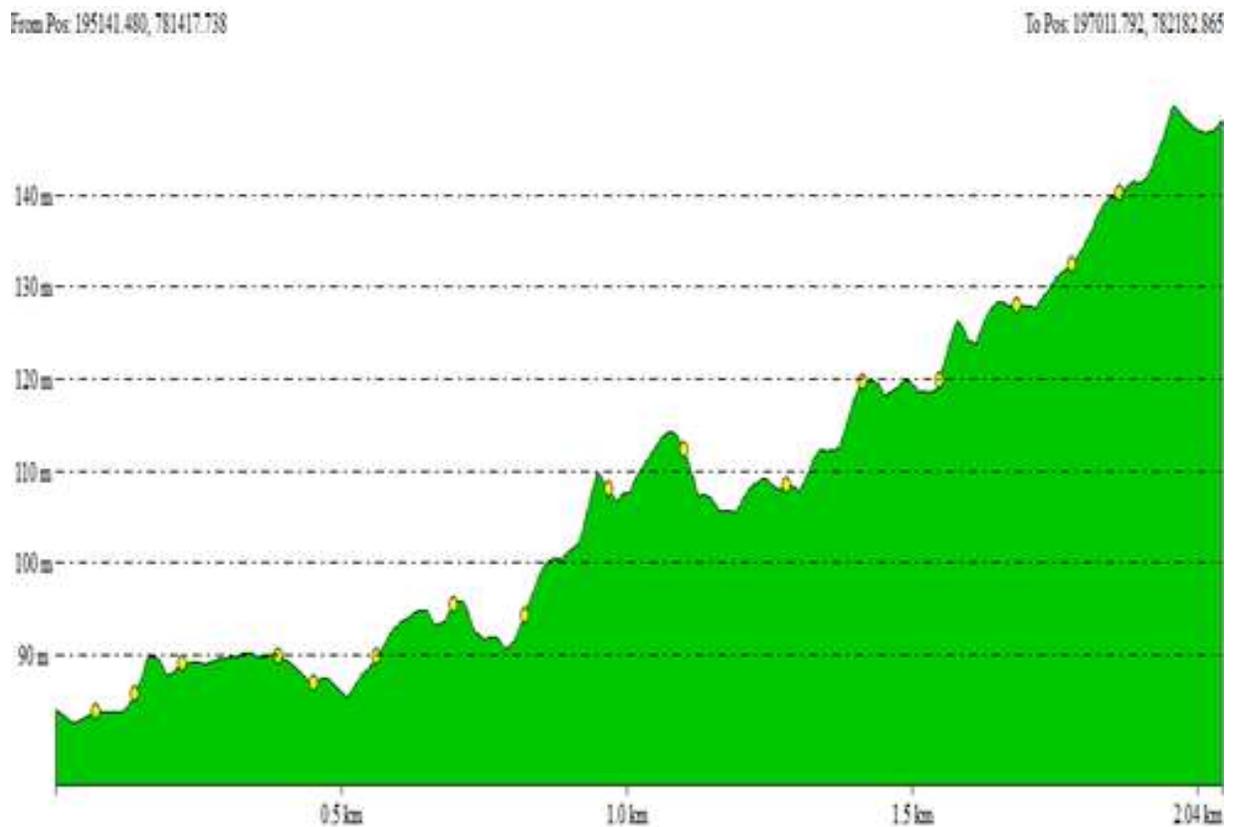
Figure 10. The slope profile of the study area plotted on global mapper using DEM of the study area.

Figure 10 details the slope profile of the study area. It shows the actual sloping and indicates how the gully has

eaten up earth material down slope. As can be seen, the slope is steep and is cutting across the land indicating erosion with a high intensity and thus huge devastating

effects. The slope profile can be used effectively in providing a basis for planning recommendations needed to address large area devastated by gully erosion and other forms of land degradation most especially where land filling method is to be adopted to reclaim land already lost due to erosion.
