Technical viability of physical soil and water conservation structures implemented in Lake Hawassa watershed, southern Ethiopia.

Yericho Berhanu Meshesha

Department of Natural Resource Management, College of Agriculture and Natural Resource, Bonga University, Bonga, Ethiopia.

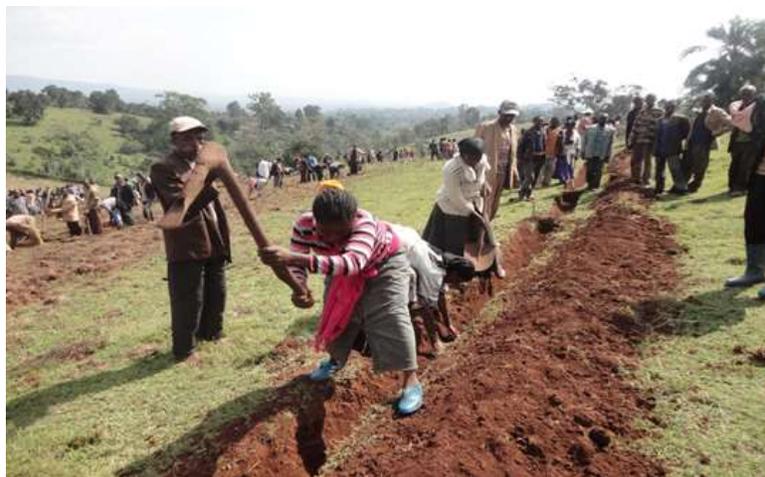
Figure 1. Soil and water conservation structure under construction.
Source: Yericho Berhanu.

Several physical conservation measures with the purpose of reducing surface runoff thereby increasing infiltration were implemented through public participation in the study area (Figure 1).

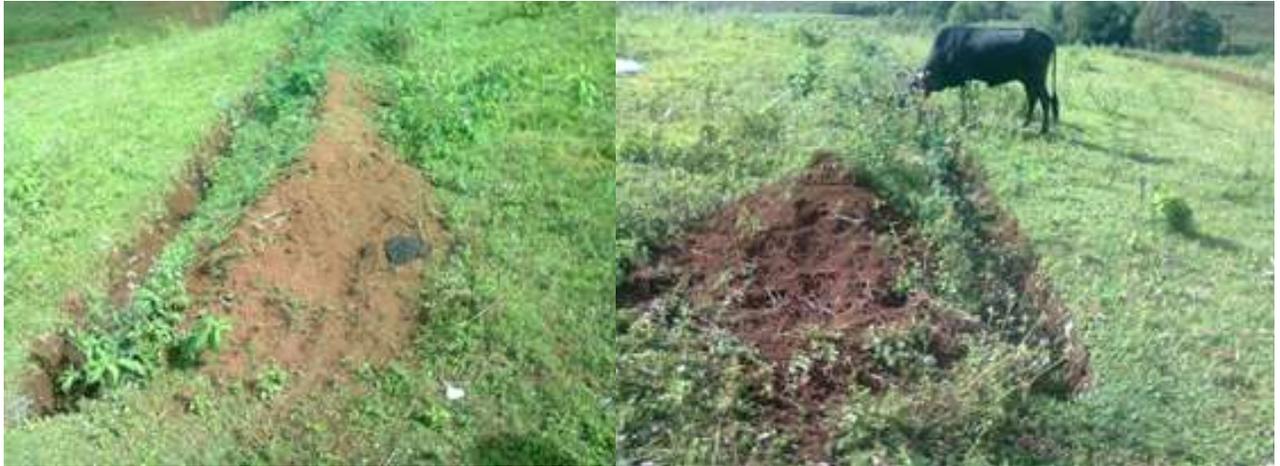
The result presented in Table 3 shows that considering the local agro-ecology and shallow soil depth stated in Hurni (1986) and Desta et al. (2005), those structures constructed in the area (both in private and public land) were appropriate for the catchment. On the other hands management and maintenance of the implemented structure in the private land is very minimal (Table 3, Figure 2).

Figure 2. Weak management and maintenance practice (Cattle heard over and destroying the structure).

national campaign program, the structures in the public land were subjected for regular maintenance via public participation. In opposite, with this, the responsibility of maintaining structures at private land were the mandate of the owner and they were less interested for its maintenance.

It is important to enhance farmers' awareness on the importance of soil and water conservation structures since most farmers believe that implementation of structure is minimizing their land area for cultivation.
